Hurricane Cyclones Case Study: Dedusting and Emission Control

Dust from cutting and scarfing operations on pressboard

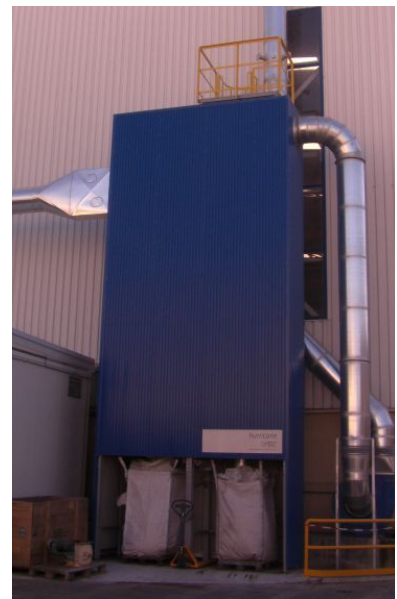
GENERAL ARRANGEMENT

The equipment is composed by a battery of 4 *Hurricanes* with Ø 900 mm. Its location is Porto, Portugal.
